INTRODUCTION: Responsibilities During Repair and About My Internship

While working at Cleveland State's Facilities Department these past 10 months (7/13/2022 – Present) my main tasks were to procure building drawings and schematics for internal department and external engineering firm use and create HVAC zone maps for buildings on campus. The biggest project I worked on is a repair project for a chilled water leak on E24th Street between Chester and Euclid Boulevards.

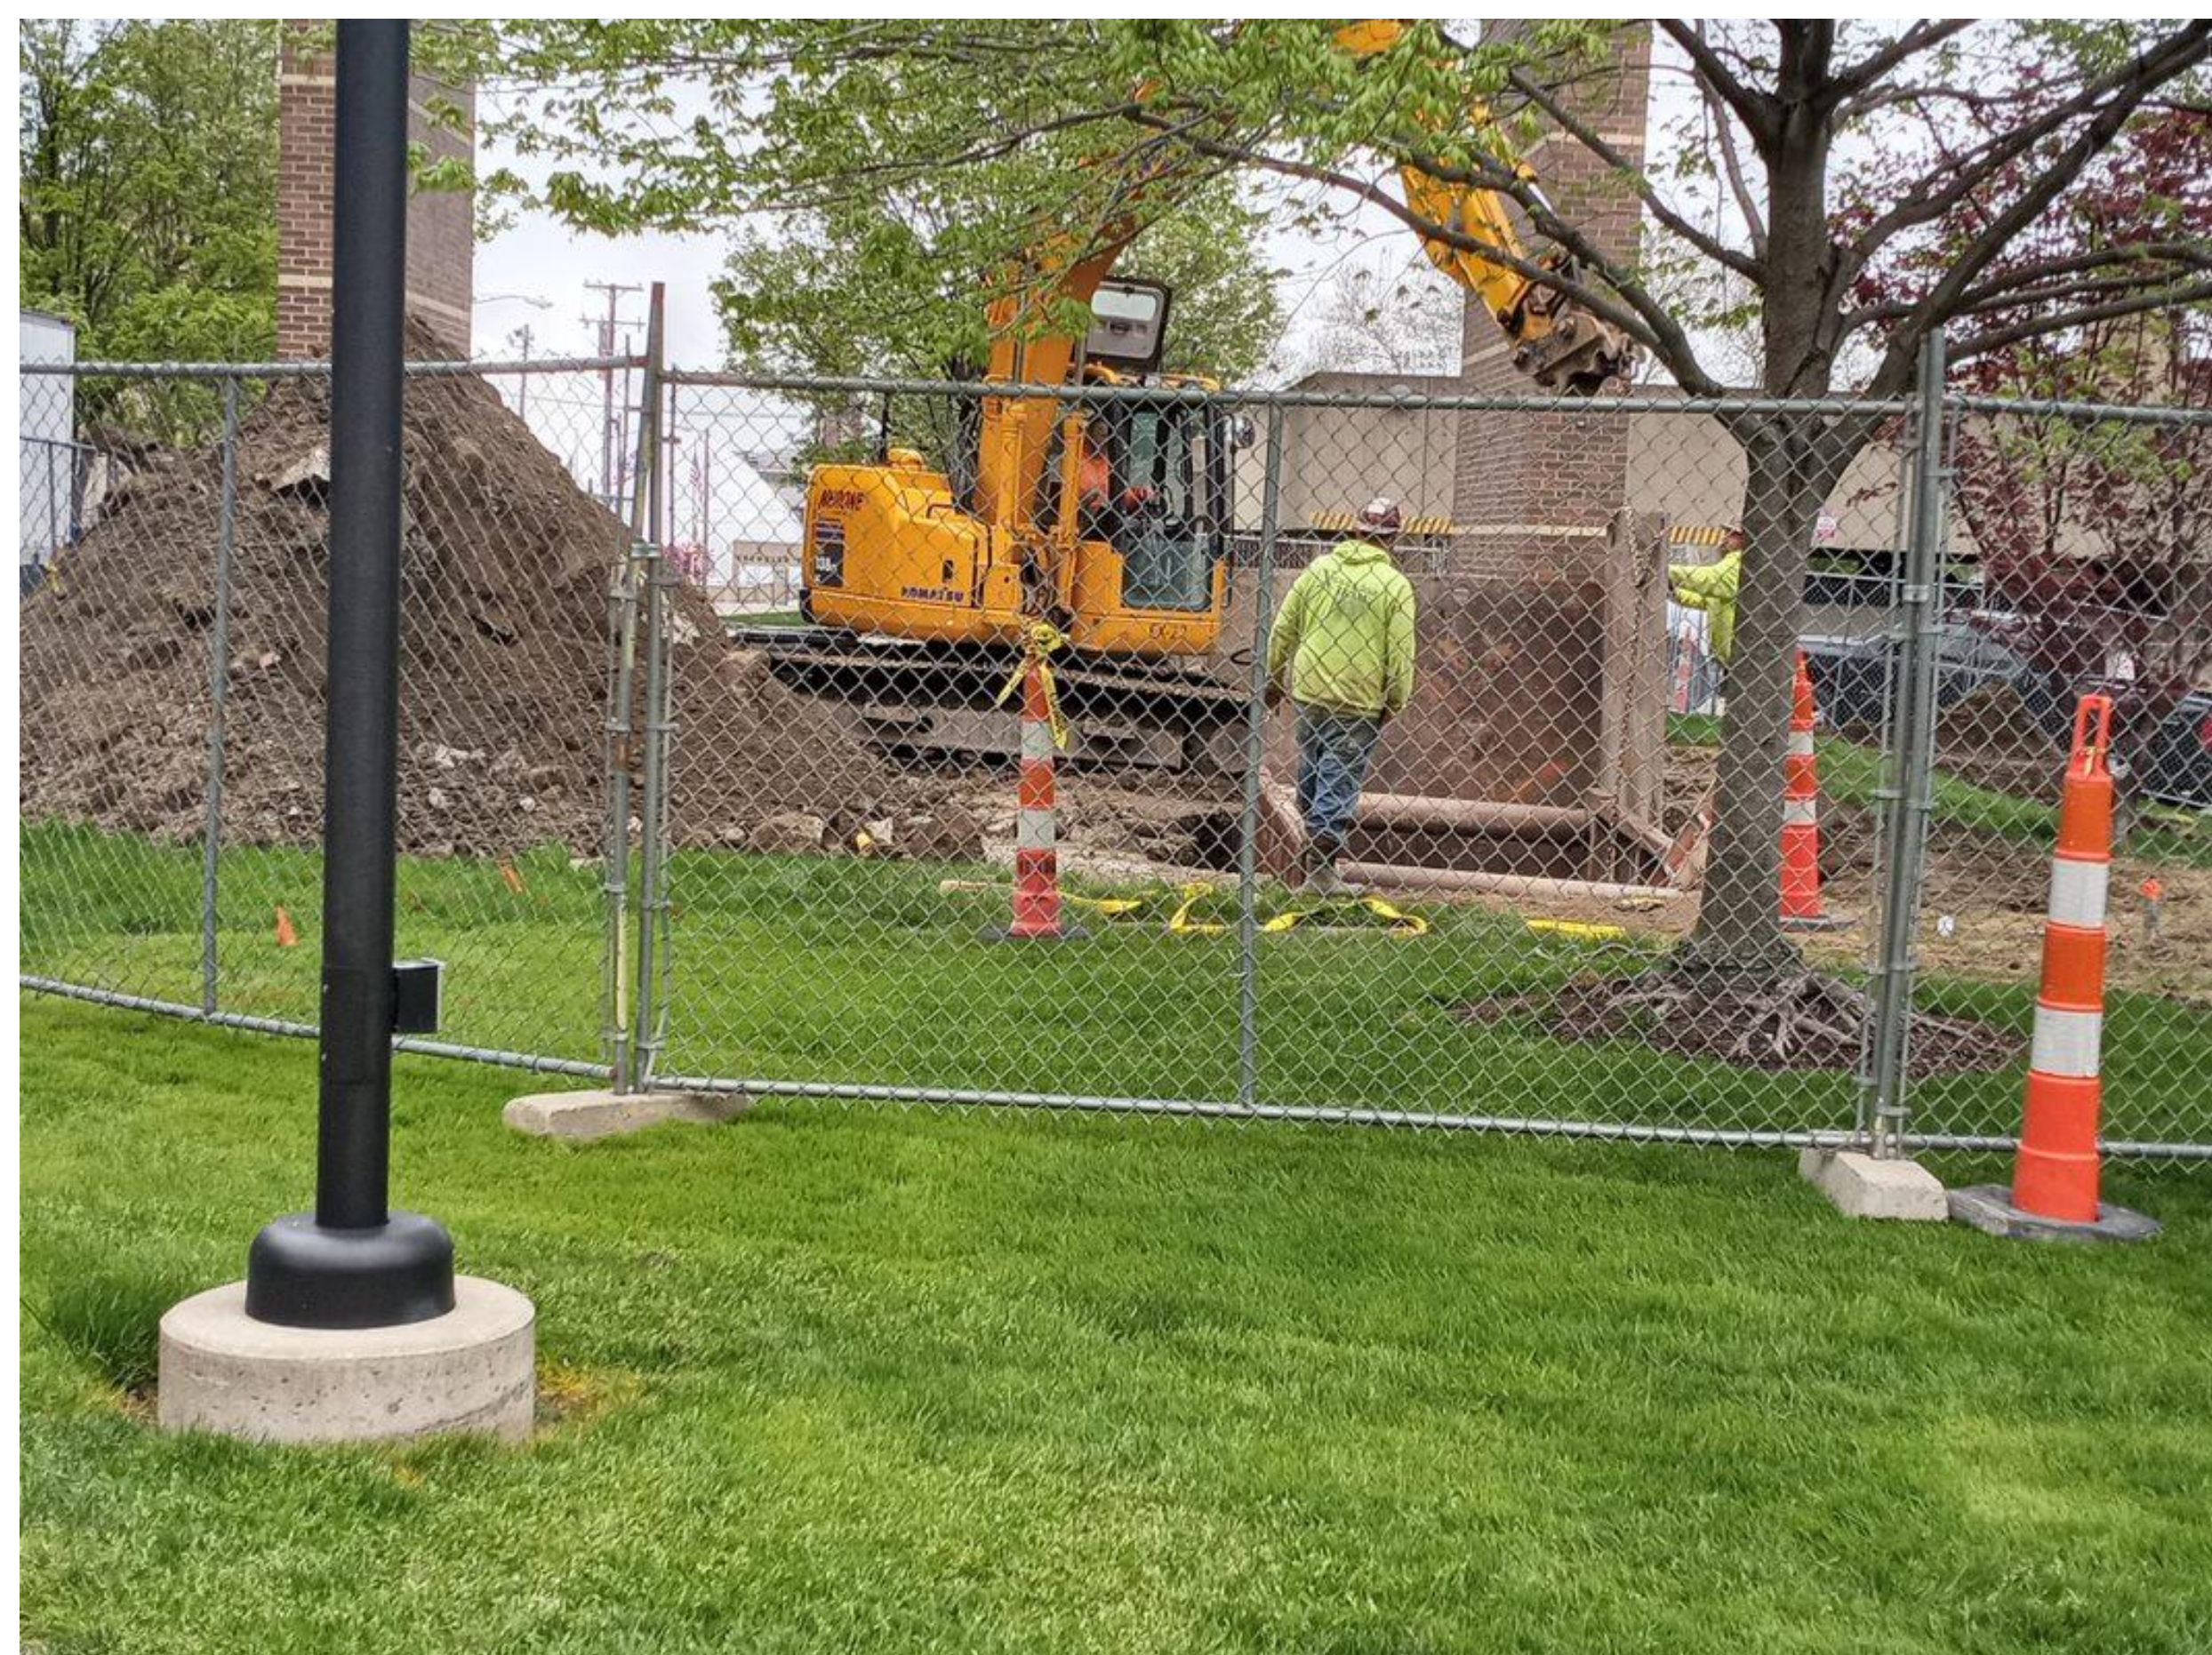
Figure 1. The location between the Law and Music Buildings being investigated.

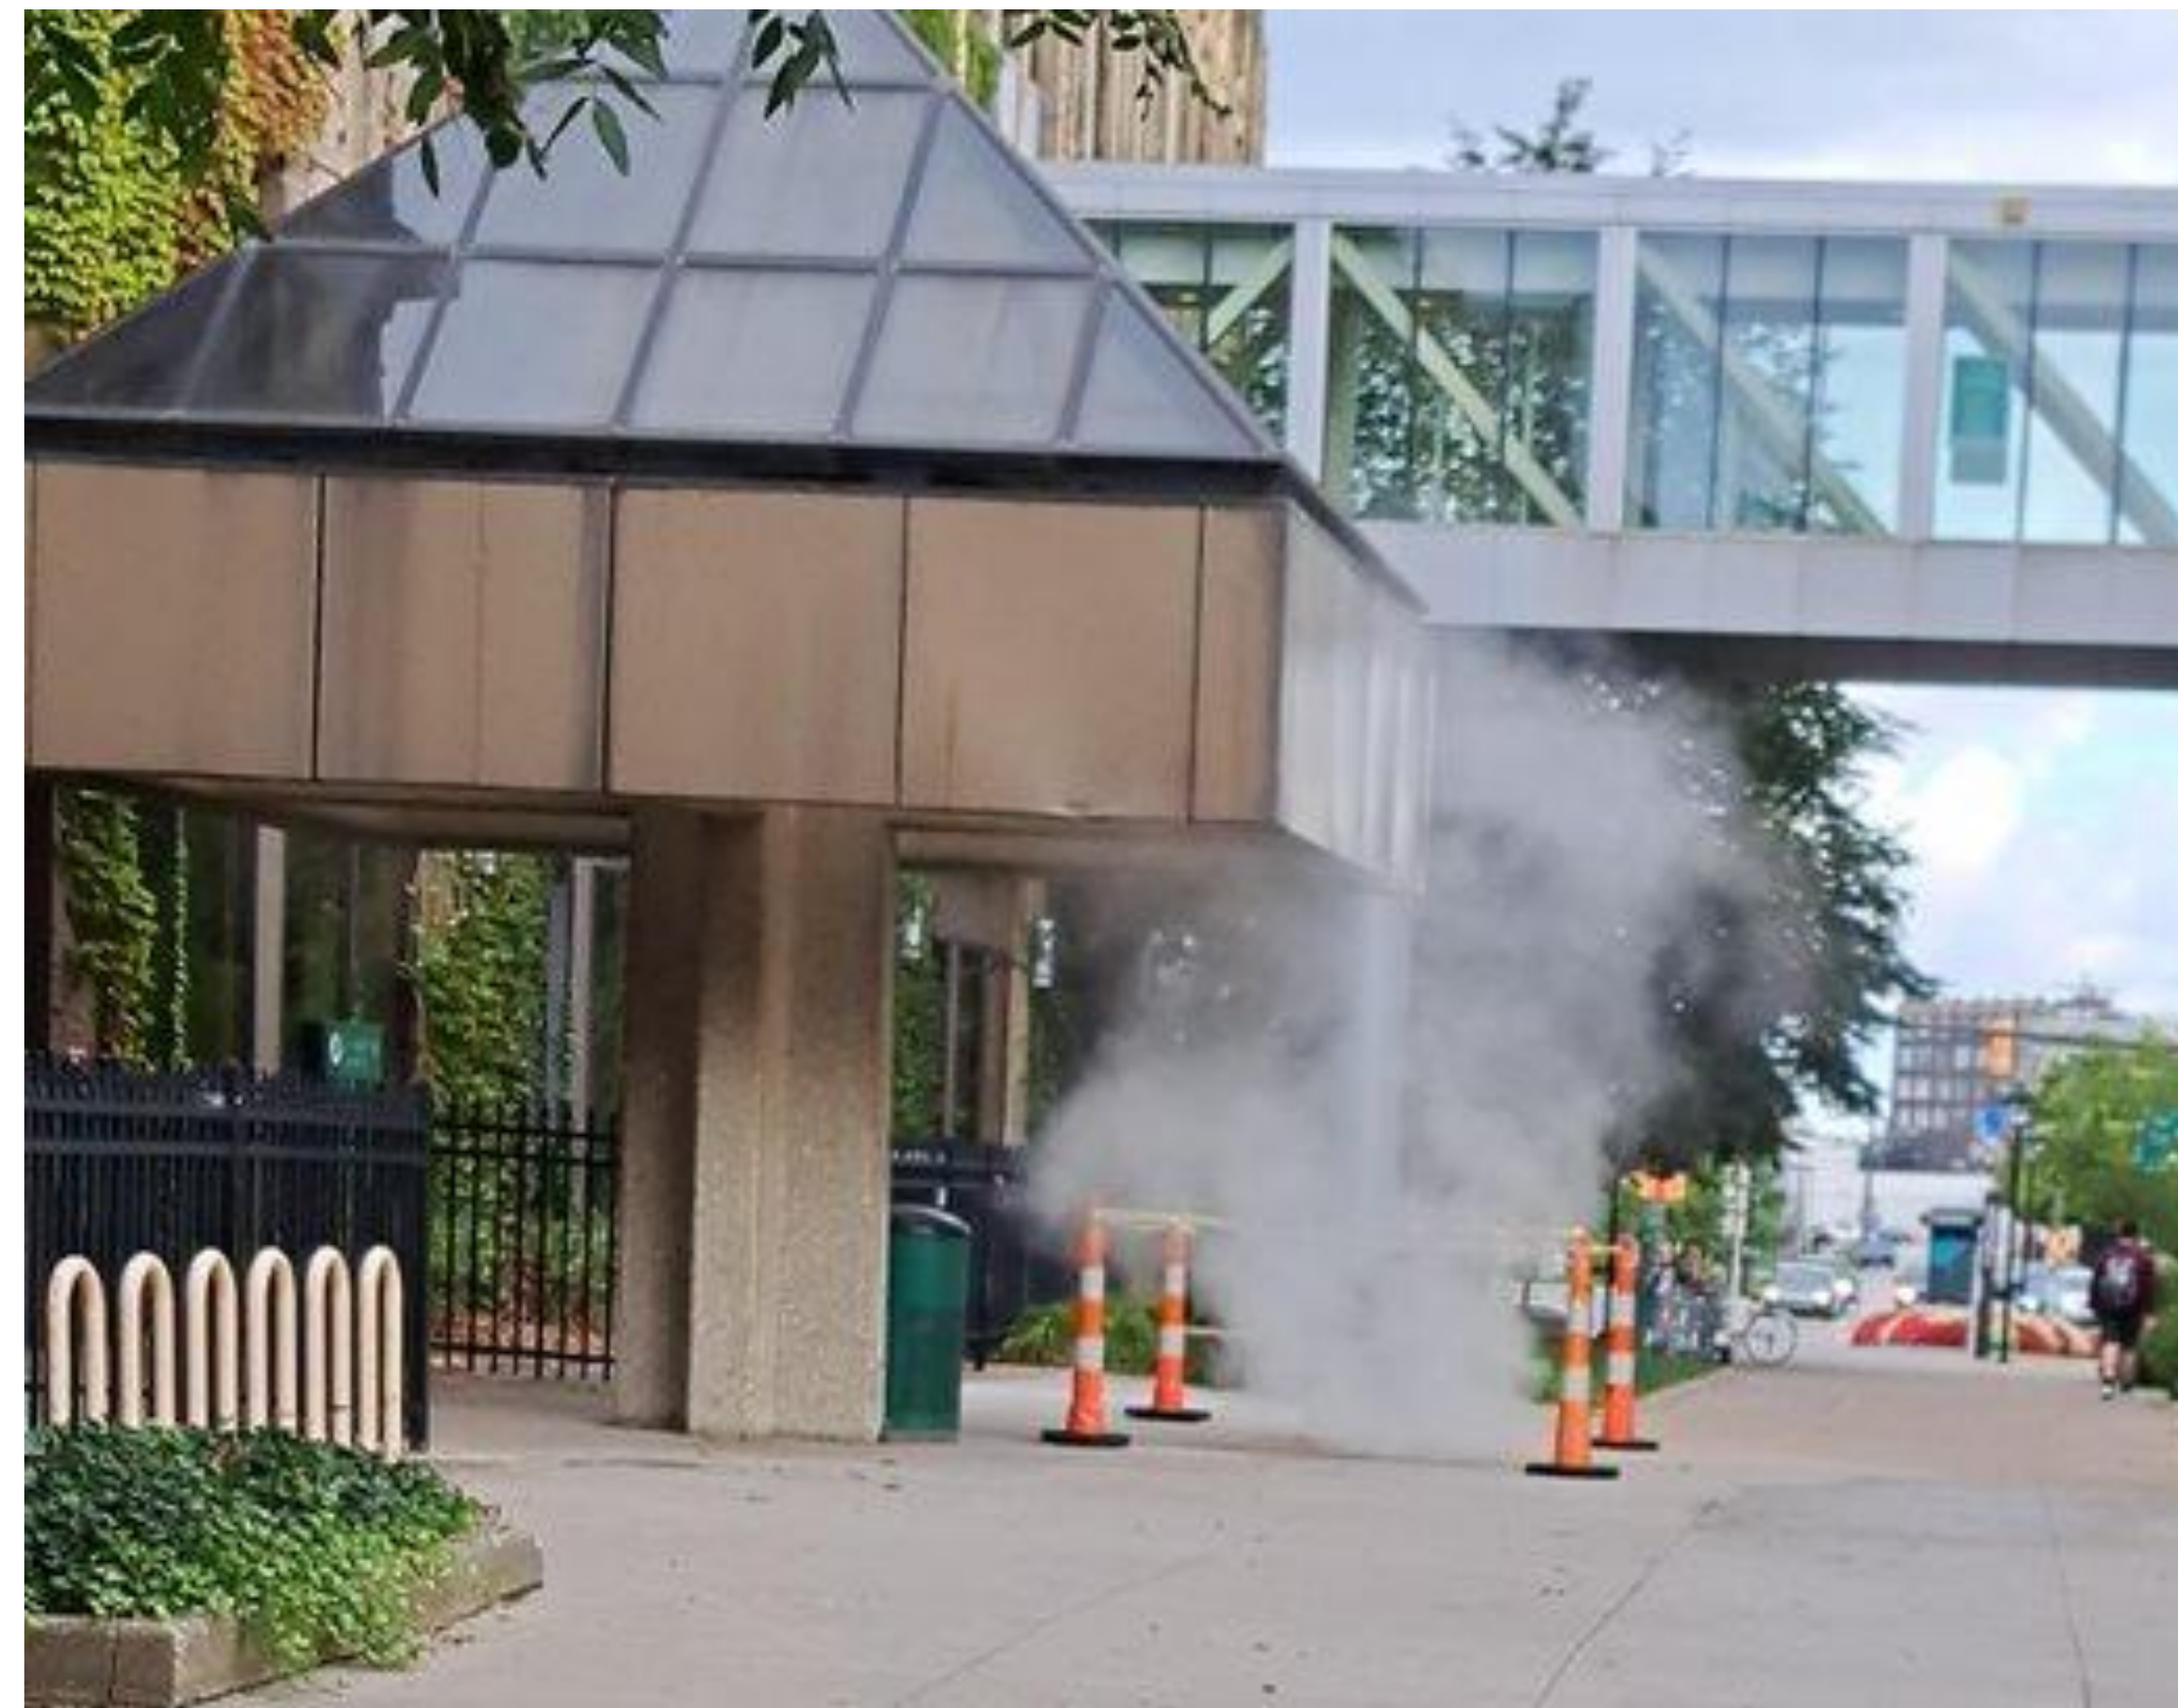
- Top floors of Rhodes Tower being way above normal temperatures.
- The cooling units on top of Rhodes Tower overheating.
- The chilled water plant losing hundreds of gallons of water. (Initial piece of evidence)
- Chilled water line having less pressure than normal.
- Acrid fumes and steam spewing from a manhole cover by the entrance to Fenn Hall

Figure 2. Steam spewing out of the manhole cover on E24th

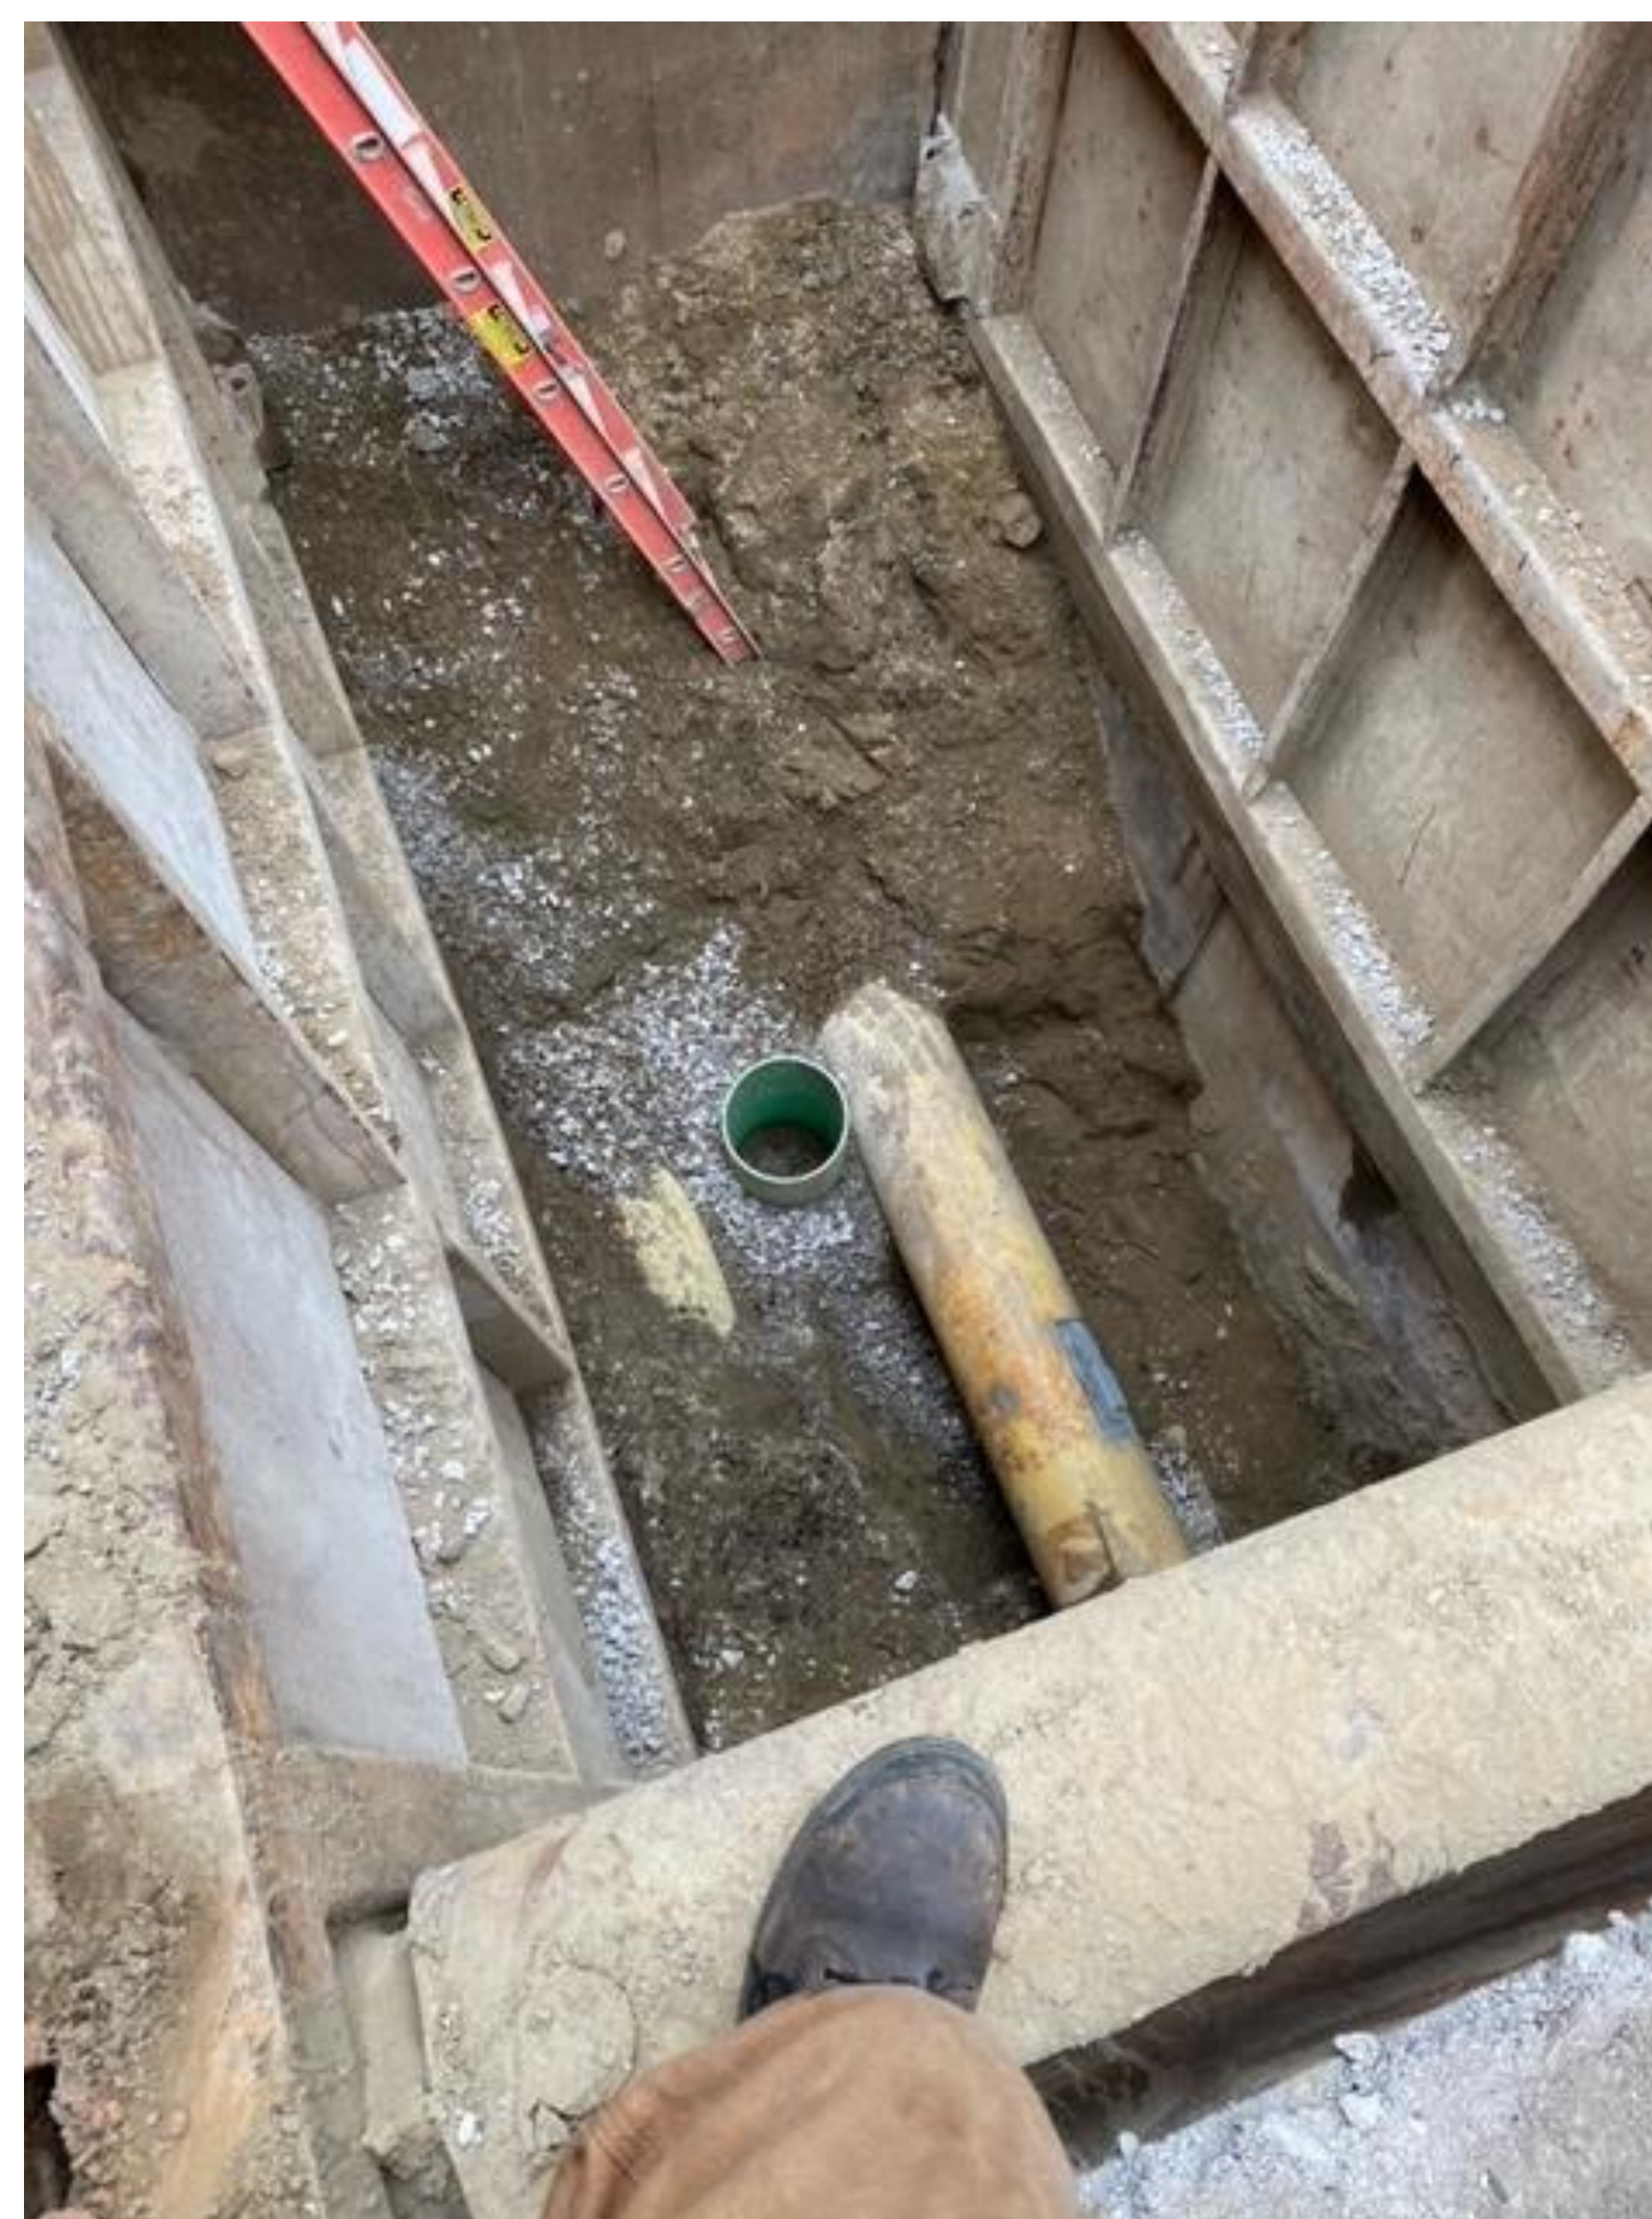
Figure 3. Chilled water pipe in question

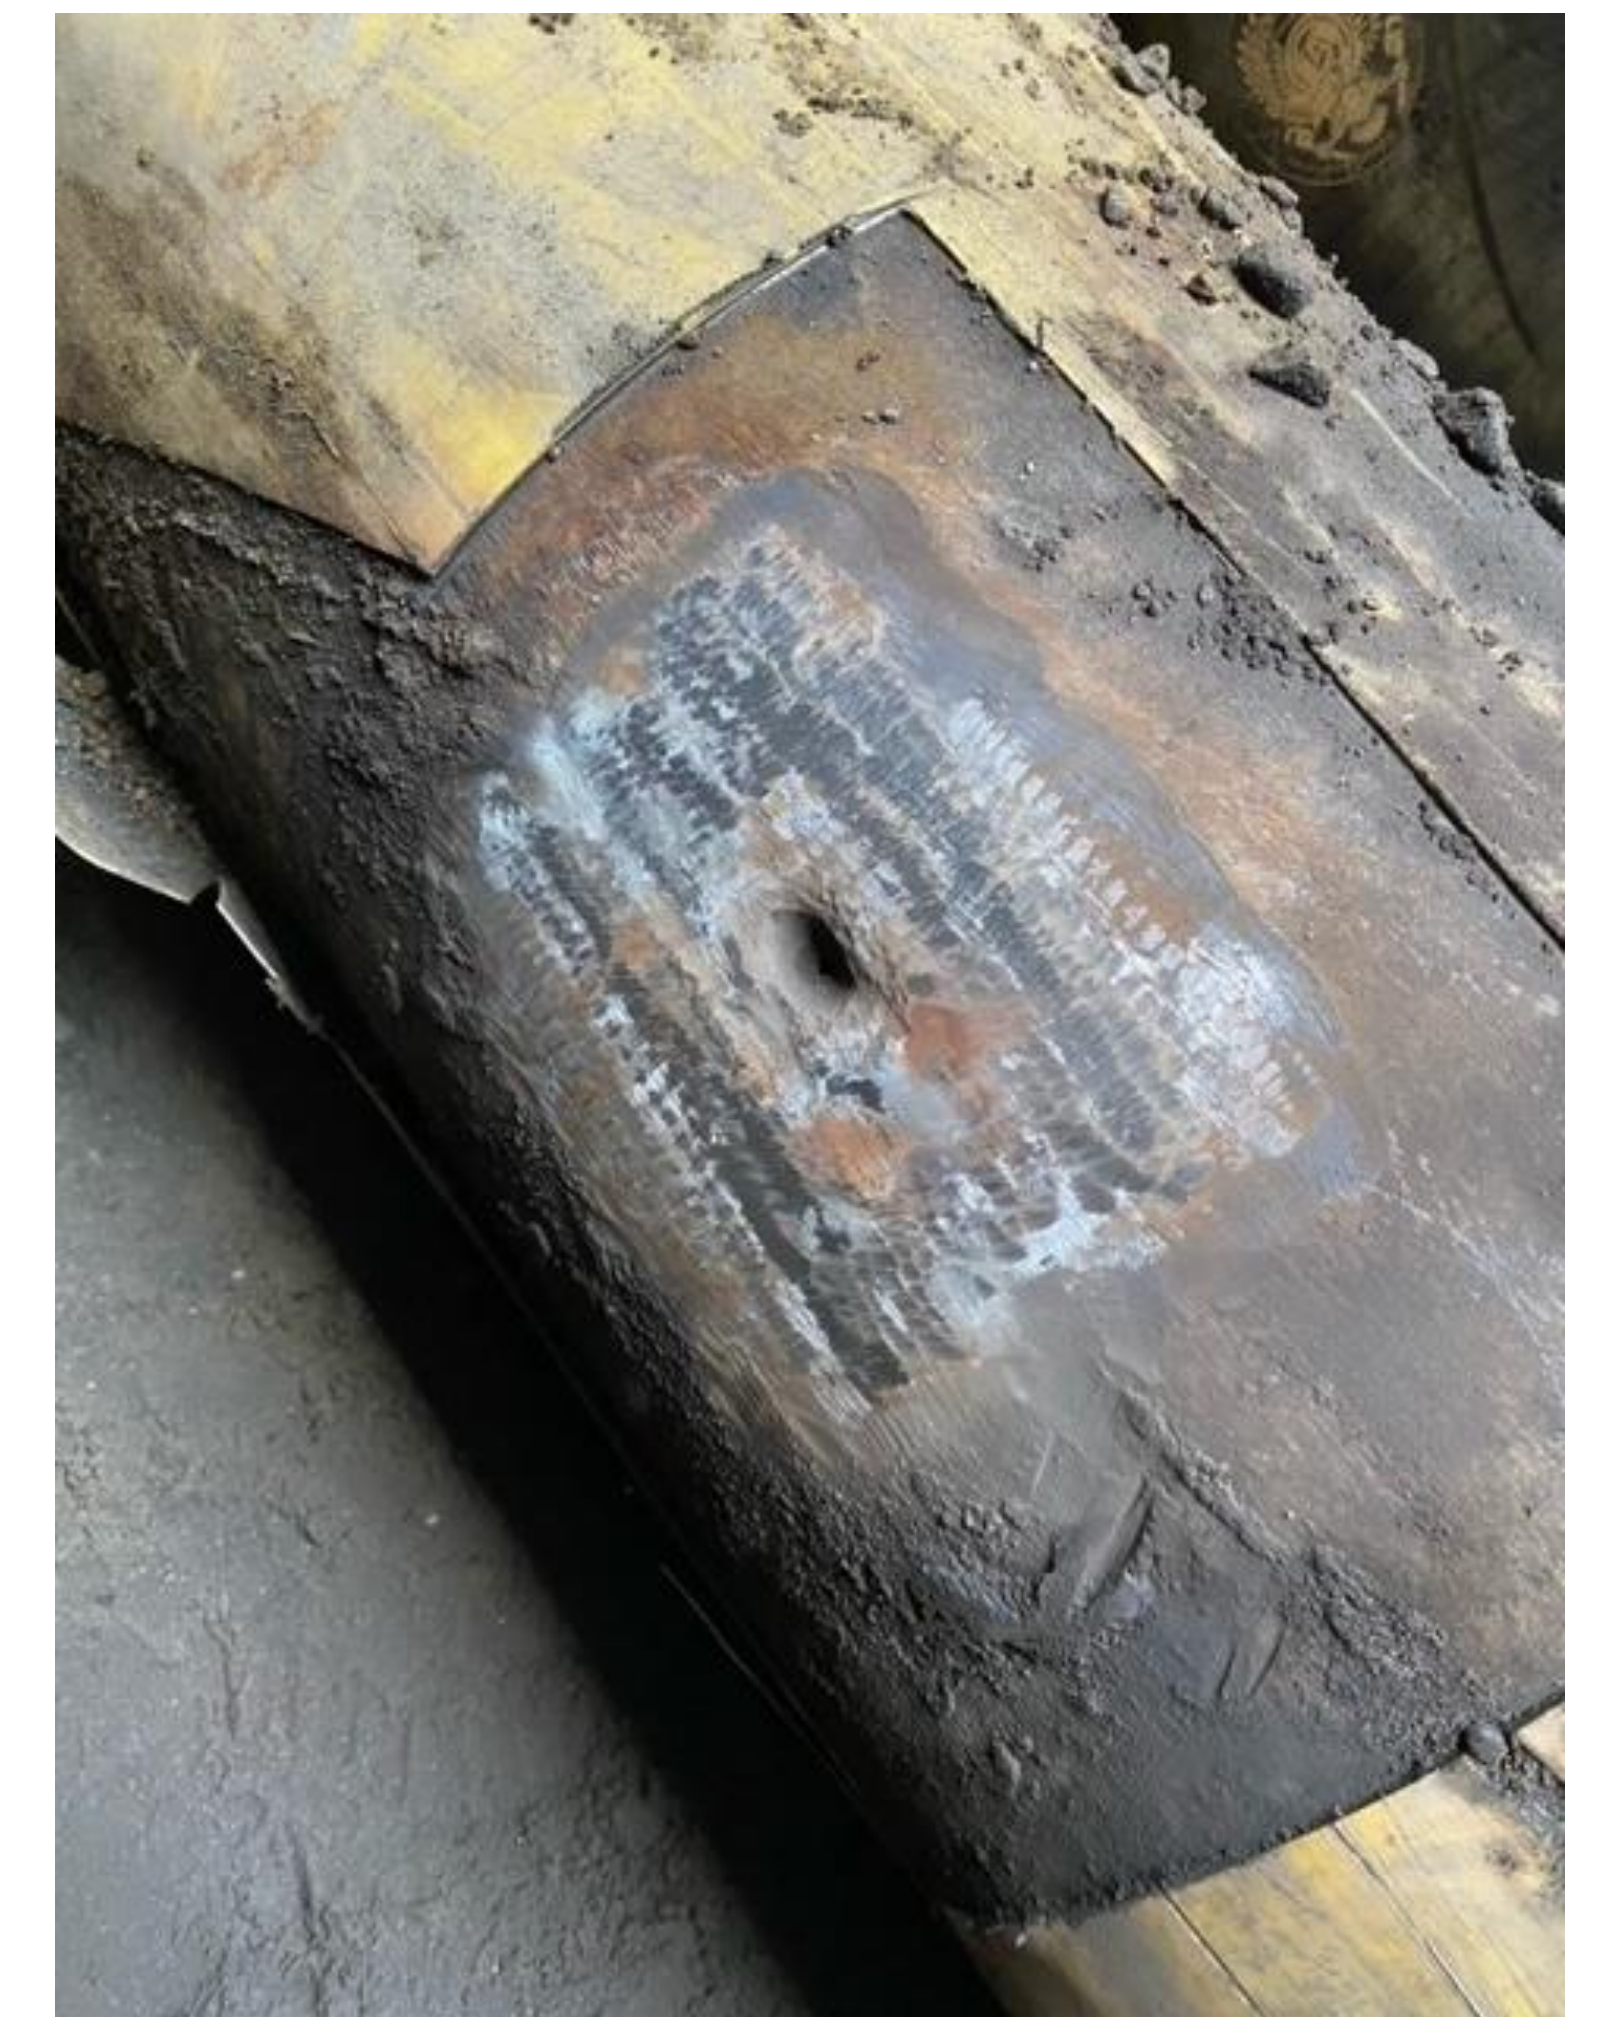
Internal technicians were initially used to find the leak in visible areas of the chilled water system; this was not useful in finding it. A leak detection company would be called out to investigate other possible locations that would end up being red herrings. The location of the leak would be discovered when mephtic steam started spewing from a manhole cover, upon further inspection by Cleveland Thermal the fumes were the mistakable smell of chilled water flashing off; the chilled water line was found to be leaking onto the nearby steam vault.

Figure 4. The hole in the pipe responsible for the leak

To pinpoint the location of the chilled water line original building plans were found for the surrounding buildings. Upon inspection of the various building plans, it was discovered that the chilled water line ran closer than previously known to the steam vault and that the drawings were not to scale. To compensate for this a vacuum truck would be called out to bore down and find the physical pipe. Once the pipe had been found Relmec would be called out to repair the damaged pipe.

Future work to prevent leaks like this or catch them quicker would entail installing isolation valves in key areas of the chilled water system, and the installation of flow and pressure sensors in other areas of importance to the system; the combination of these features would allow future leaks to caught and isolated before major damage occurs.
